CIRCULAR NO. M-2

Centre-Beam Cable Condemning Limits and Replacement Procedures

Effective: March 30, 2011

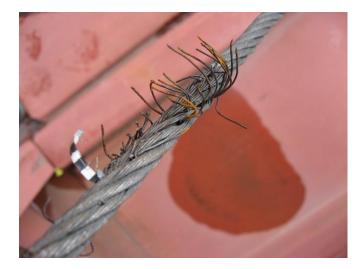
b) Broken cables:

- 1. Any cable depicting one or more of the following defects should be replaced on sight:
 - a) Frayed cables with more than thirteen wires broken at any one location or one broken strand:

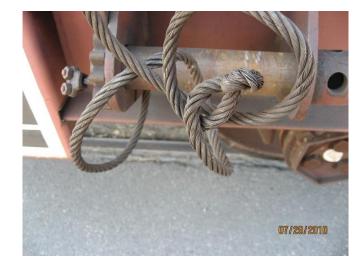
d) When knots cannot be removed and interfere with proper winding of cable (improperly wound cable)

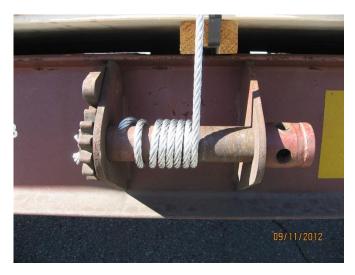
Properly wound cable

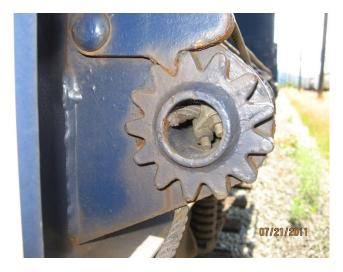
Cable U-Bolt Clamp properly installed

- a) Cable tail must not protrude more than 6 inches outside of ratchet barrel
- b) Bolted clamp must be properly fitted inside the ratchet barrel and tight against the hole on the barrel
